EIELSON AIR FORCE BASE INFILTRATION POND STUDY

March 1996

Final Technical Report for the Period 24-28 July 1995

EIELSON AIR FORCE BASE, ALASKA, INFILTRATION POND STUDY

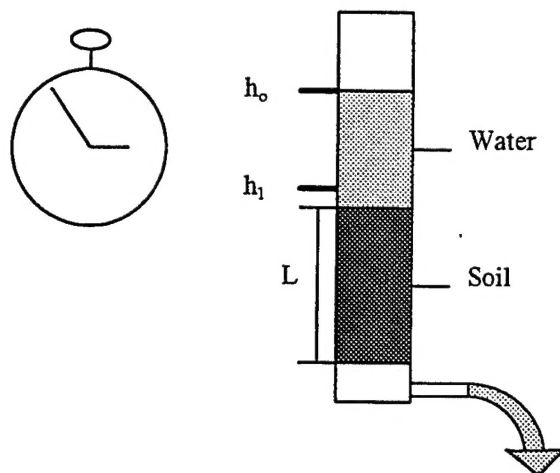
FIGURE 1.
FALLING HEAD PERMEABILITY TEST

To assess the permeability of the sediment, OEB personnel attempted to conduct an on-site test. In this procedure, water is placed on top of a column of the sediment, and the time for the water level in the test column to fall a specified distance is measured. Figure 1, below, illustrates the method.

The hydraulic conductivity of the soil, k , is calculated by the equation, $k = L/t \ln(h_0/h_1)$, where t is the amount of time it takes the water level to drop from h_0 to h_1 (Adapted from Freeze & Cherry, 1979), and L is the length of the soil column.

The low conductivity of the sample, however, made it impossible to conduct this test in the field because there was no visible migration of the water through the sludge column. Thus, OEBW sent a batch of the sludge to the Soil and Crop Science laboratory at Texas A&M University. In a similar test, Texas A&M placed an aliquot of the sludge into a plastic double ring infiltrometer, designed by McNeal & Reeve (1964). Water was loaded on top of the sample, and the effluent water volume measured over the course of 5 days to determine the hydraulic conductivity of the sludge. See Appendix B for the laboratory report of the permeability test.

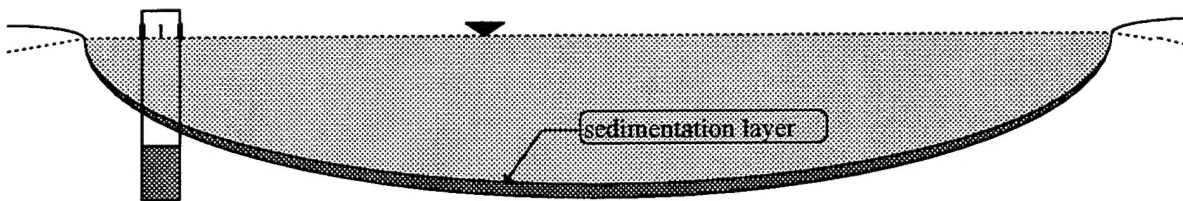
FIGURE 2.
STAND PIPE DIAGRAM

6. EAFB could install several (6-12) stand pipes to handle overflow conditions. Figure 2, below, illustrates this option. The stand pipes would be 12 to 24 inch diameter pipes set below the impermeable layer. The section of the pipe below the sediment layer would be screened or slotted to allow migration of water through this section. When the pond levels reach the height of the influent slots on the stand pipe, the water would percolate into the underlying strata. The bottom sediment would have to be cleaned from the standpipe before the pipes would operate properly. These pipes could be installed near the shore line.

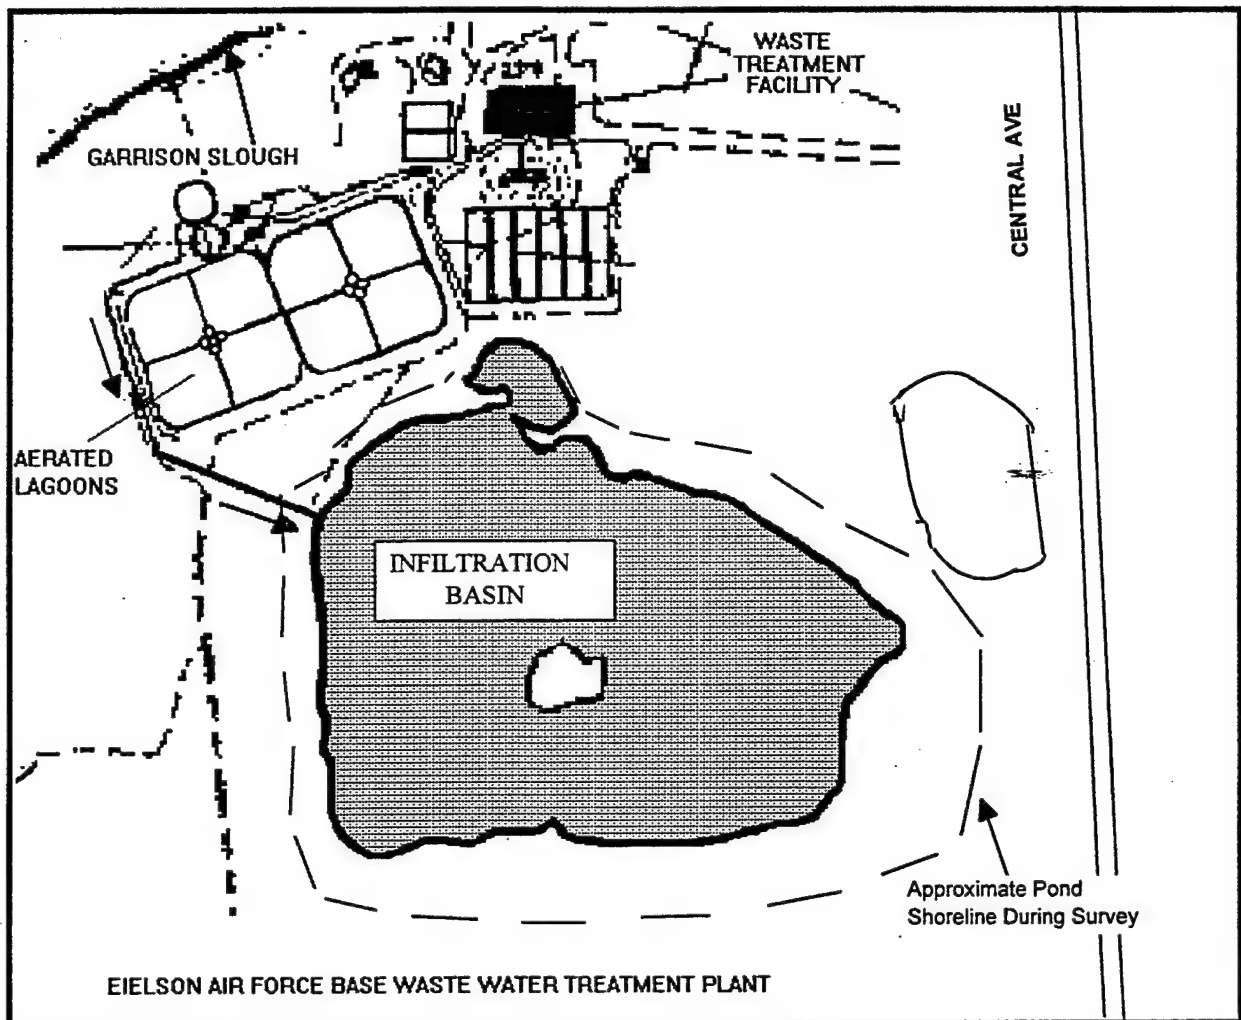
FIGURE A-2
INFILTRATION BASIN

Figure A-1 of Appendix A shows the site location map for the WWTP infiltration basin. It was apparent during the survey that the infiltration pond has become larger than it has historically been. Figure A-2 Shows the approximate shoreline location during the survey. A barbed wire fence around the original perimeter of the pond was almost completely submerged in the water at the time of this survey. WWTP personnel indicated that this fence was entirely above the water in the past. Figures A-3, A-4, and A-5 of Appendix A provide photos taken on 28 September 1995, which show how the water extends beyond the fence line. OEBW believes that the water level was higher during the survey than at the time of these photographs, but does not have pictures for comparison.

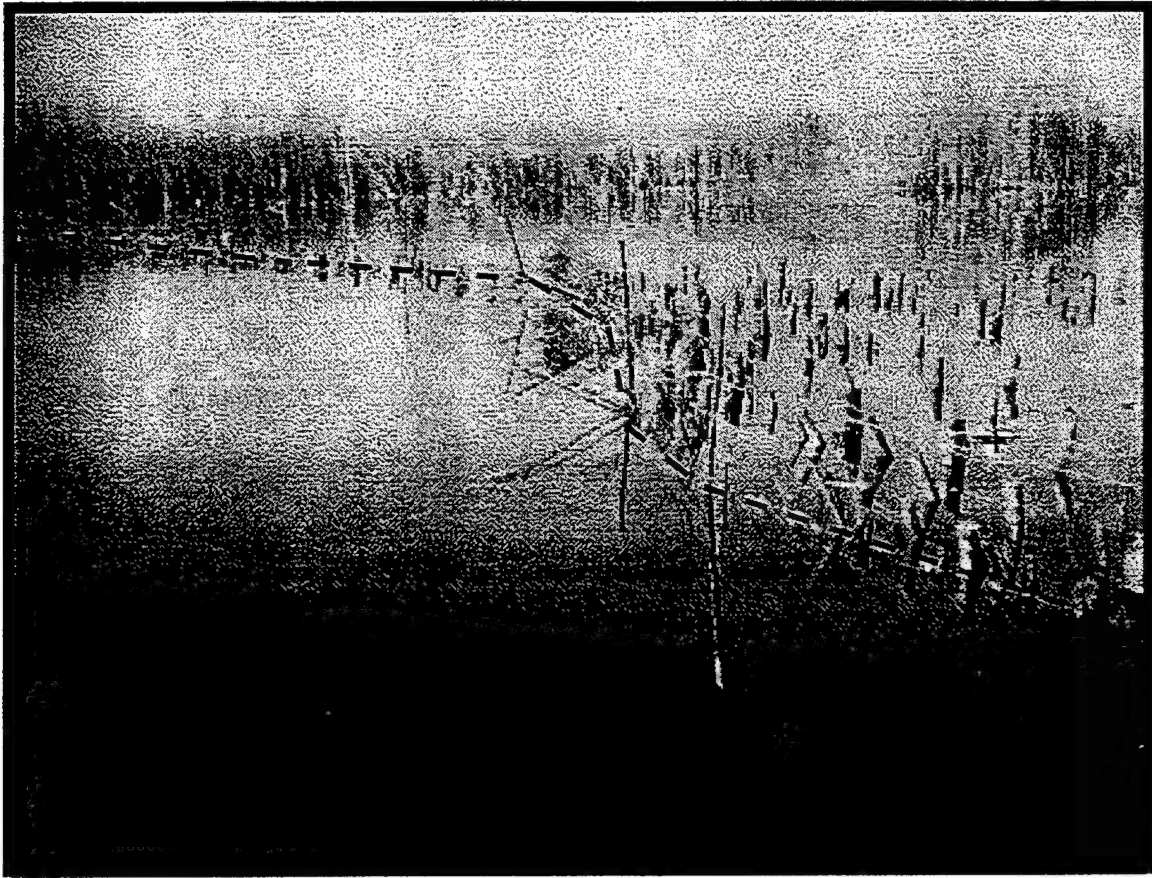
FIGURE A-4
EAST END OF POND, 28 SEP 95
(Dotted line shows fence location)

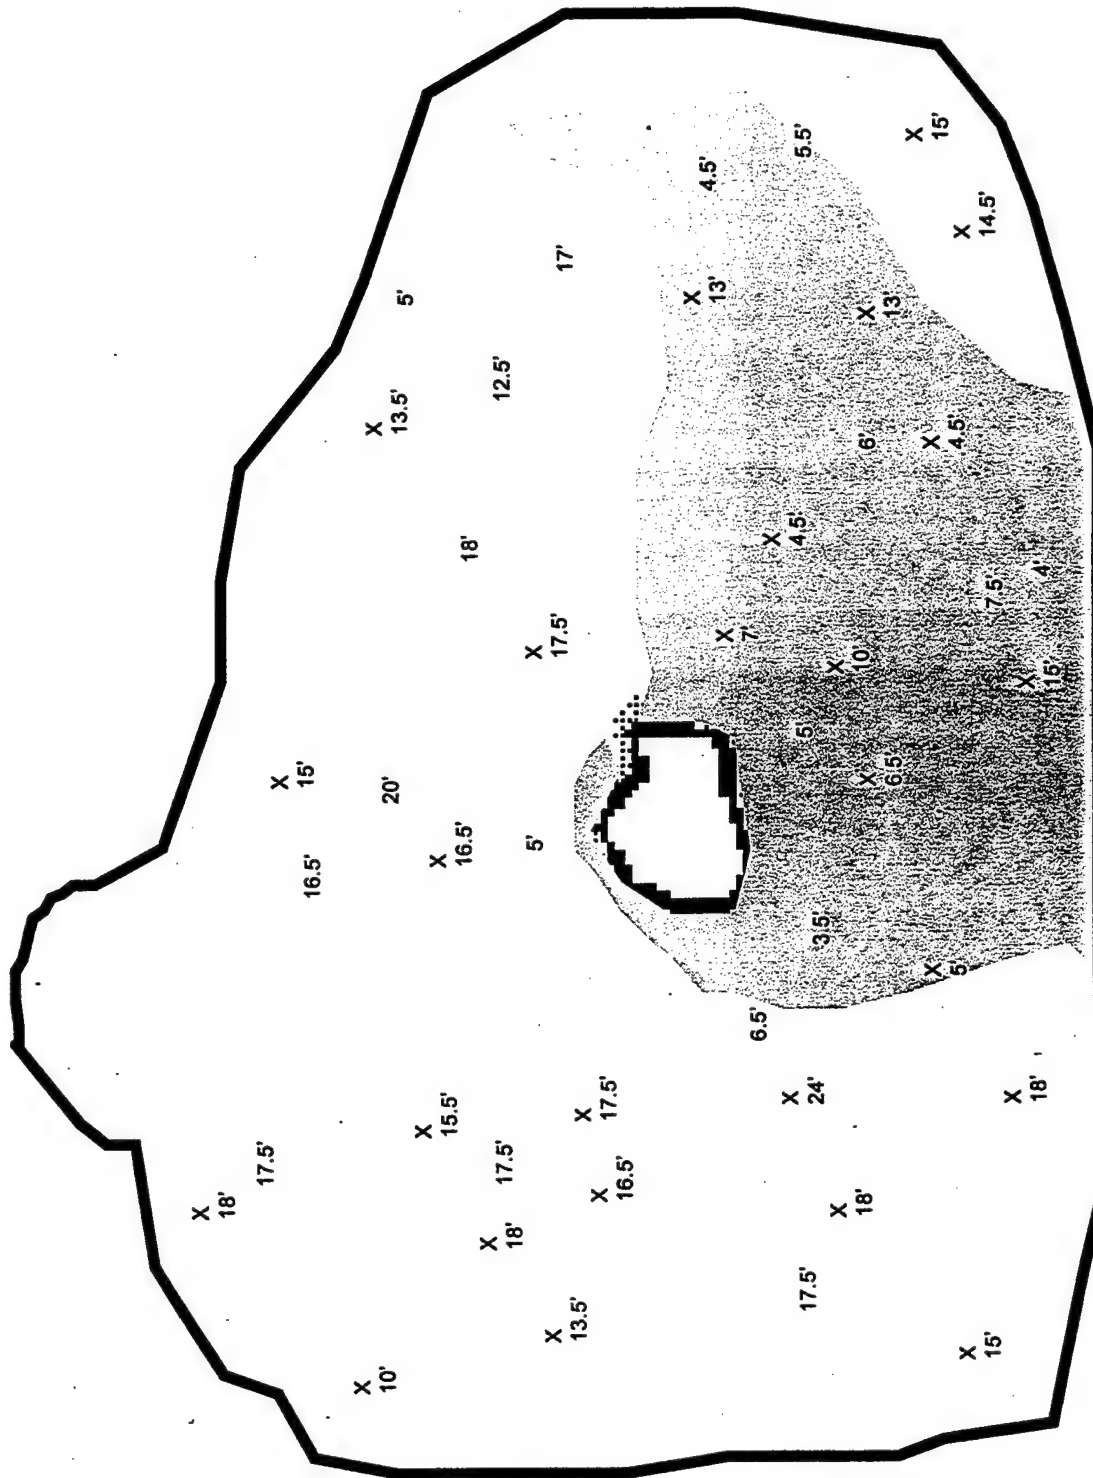
FIGURE A-6. INFILTRATION BASIN SAMPLING LOCATIONS AND DEPTH MEASUREMENTS

Figure A-6 shows the approximate location of sediment samples, and the water depth at each location. The sediment in the infiltration basin was dark green in color and had a mild odor of decaying biological matter. The character and consistency of the sediment was fairly constant throughout the pond, except at locations to where the pond had recently extended. At these locations, OEBW observed significant amounts of coniferous needles, leaves, sticks, and bark or grass, and little collectible sediment. These locations were near the edges of the pond where tree stumps and the surrounding barbed-wire fence protruded from the water. This information, along with past aerial photos, indicate that the pond has not always covered these areas, and that it is, indeed, increasing in size.

X - Marks Sampling Location

- Indicates Areas with Tree Stumps

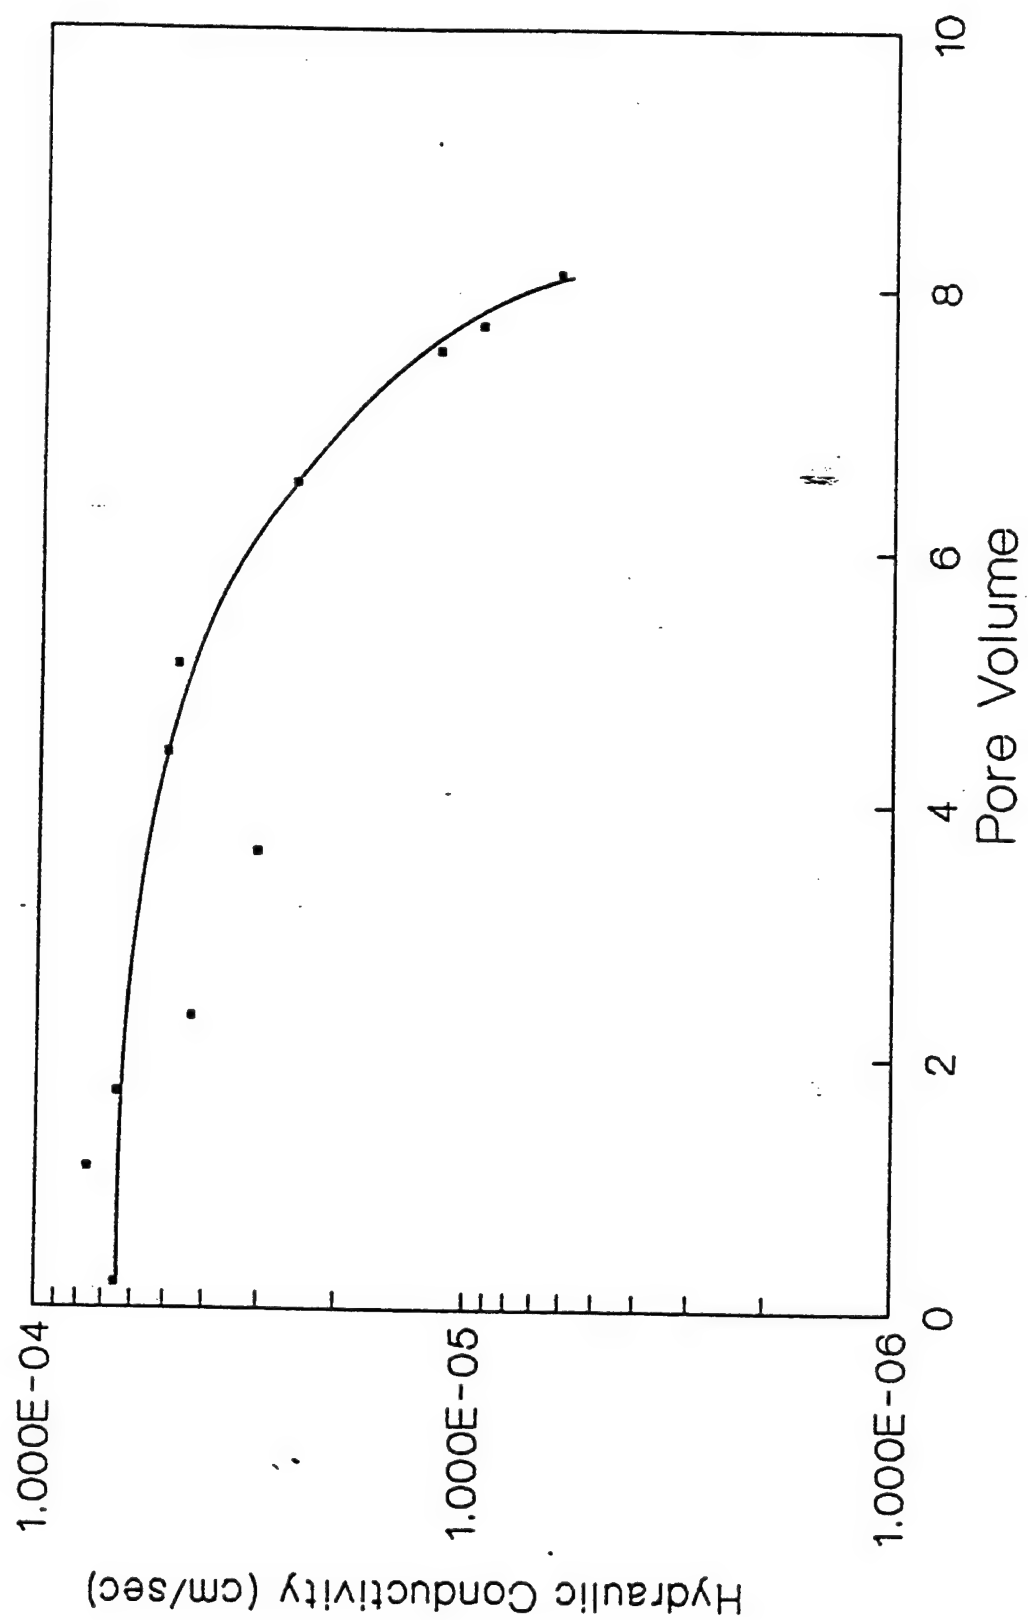
The hydraulic conductivity as a function of pore volume is presented in the following table and is shown graphically in the attached figure.

The sample had an initial hydraulic conductivity of about 6.5×10^{-5} cm sec⁻¹ over the first two pore volumes of effluent. Some particle migration was observed as sediment in the outflow tube and collection vessel. The hydraulic conductivity then showed a steady decrease until by the passage of 8 pore volumes of leachate the conductivity had decreased by 1 order of magnitude to 6.1×10^{-6} cm sec⁻¹.

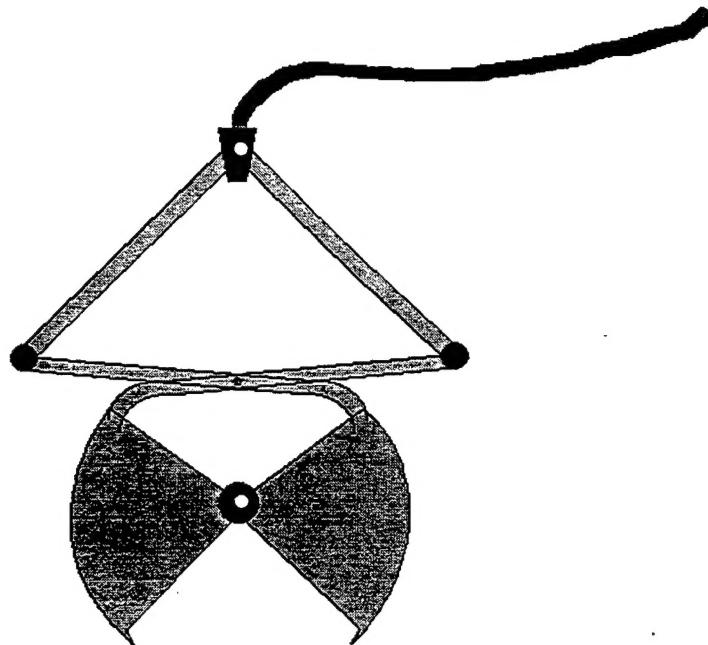
PONAR DREDGE SAMPLER

In order to characterize the sediment for disposal alternatives, equal amounts of sludge samples from each sampling location were collected with a ponar dredge and placed into a large glass jar. This composite sample was thoroughly mixed, and aliquots taken and placed in the appropriate sample containers for Toxicity Characteristic Leachate Procedure (TCLP) analyses. The TCLP procedures included metals, pesticides, herbicides, volatile and semivolatile organic compounds, and reactivity. OEB personnel took duplicate samples for quality control purposes to insure the reproducibility of the analytical results.
